OBERHEIM ELECTRONICS, INC.
ENGINEERING CHANGE ORDER

ECO NO.
201

DSX

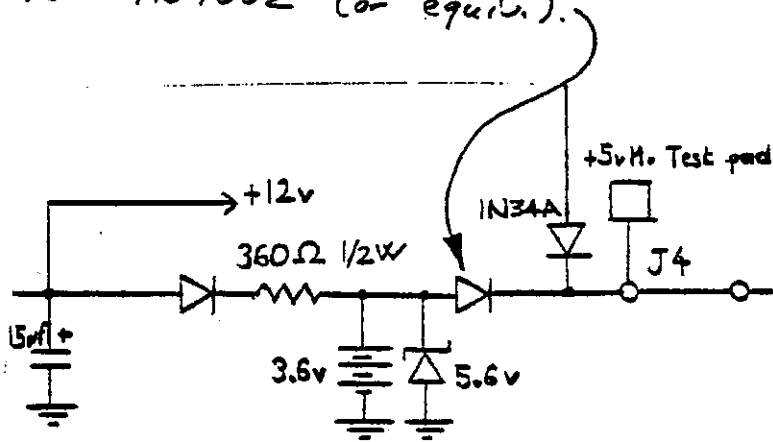
Occasionally the 1N4148 opens & then battery backup does not work.

Change 1N4148 diode in battery backup circuit to 1N4002 (or equiv.).

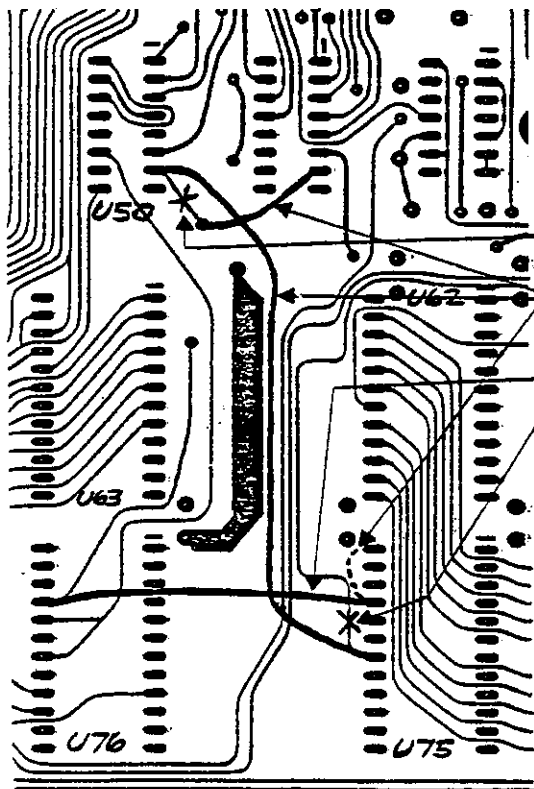
- BACK OF PROCESSOR BOARD -

TO ALLOW FOR EXTRA STORAGE OF NEW SOFTWARE BY CHANGING U75 FROM A 2716 E-PROM TO A 2732 E-PROM.

1. REMOVE DSX PROCESSOR BOARD BY DISCONNECTING CONNECTORS A THROUGH E AND UNSCREWING THE TEN SCREWS.
2. REMOVE JUMPER BETWEEN U75 PIN 24 AND U75 PIN 21 ON BACK OF BOARD.
3. CUT TRACE BETWEEN U75 PIN 18 AND U46 PIN 9 ON BACK OF BOARD.
4. CUT TRACE BETWEEN U50 PIN 7 AND FIRST FEED-THROUGH ON BACK OF BOARD.
5. ADD JUMPER BETWEEN U50 PIN 7 AND U75 PIN 18 ON BACK OF BOARD.
6. ADD JUMPER BETWEEN U75 PIN 21 AND U76 PIN 21 ON BACK OF BOARD.
7. ADD JUMPER BETWEEN U49 PIN 7 AND FEED-THROUGH ON BACK OF BOARD.
8. PLACE BOARD BACK IN CHASSIS AND RECONNECT ALL CONNECTORS AND SCREWS.
9. REPLACE E-PROMS:
E-PROM 'C0' GOES INTO U76
E-PROM 'C1' GOES INTO U63
E-PROM 'C2' GOES INTO U75

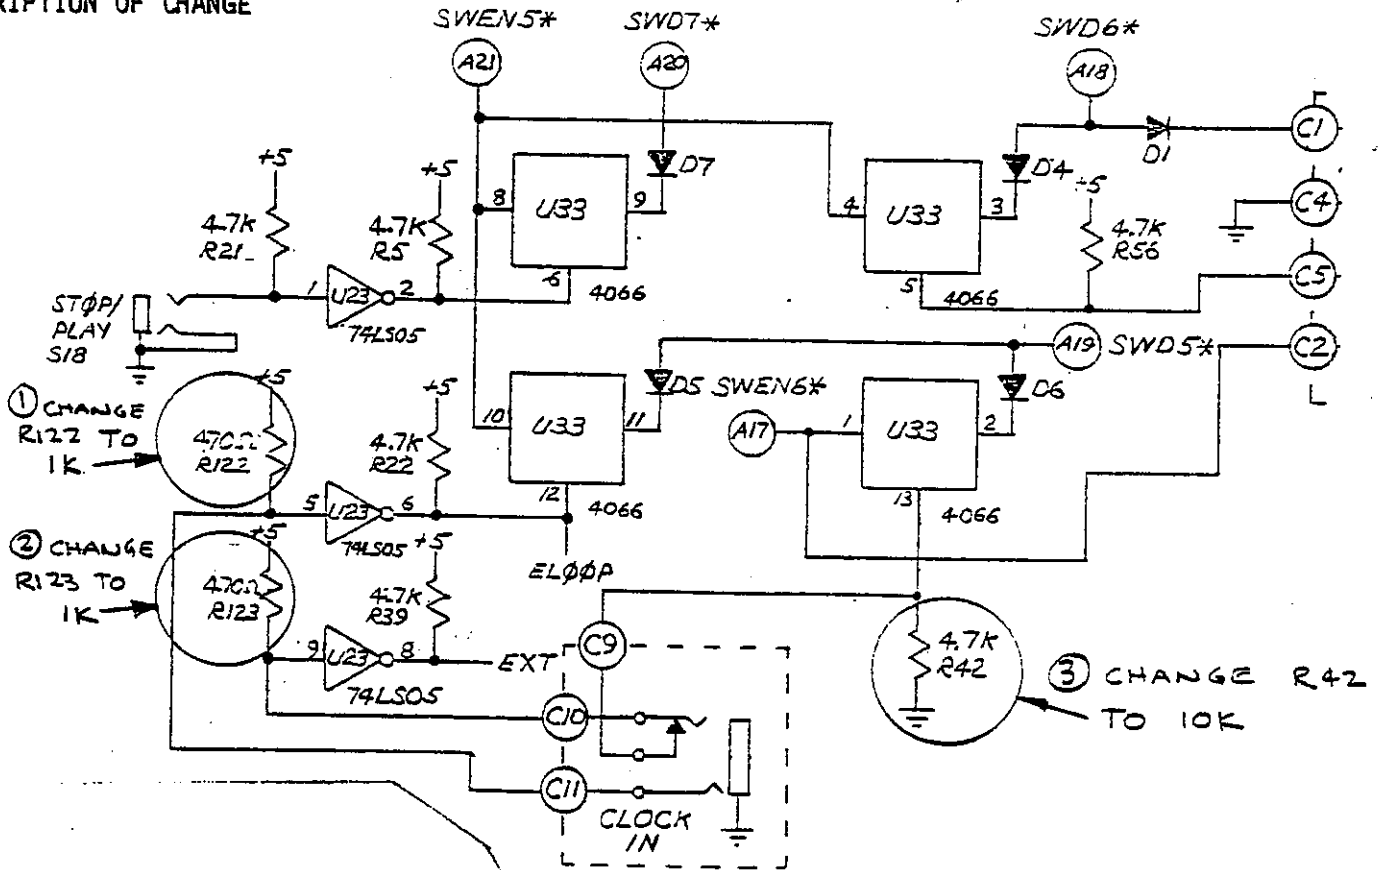
TO REDUCE CLOCK NOISE WHEN DSX IS SLAVED TO DMX

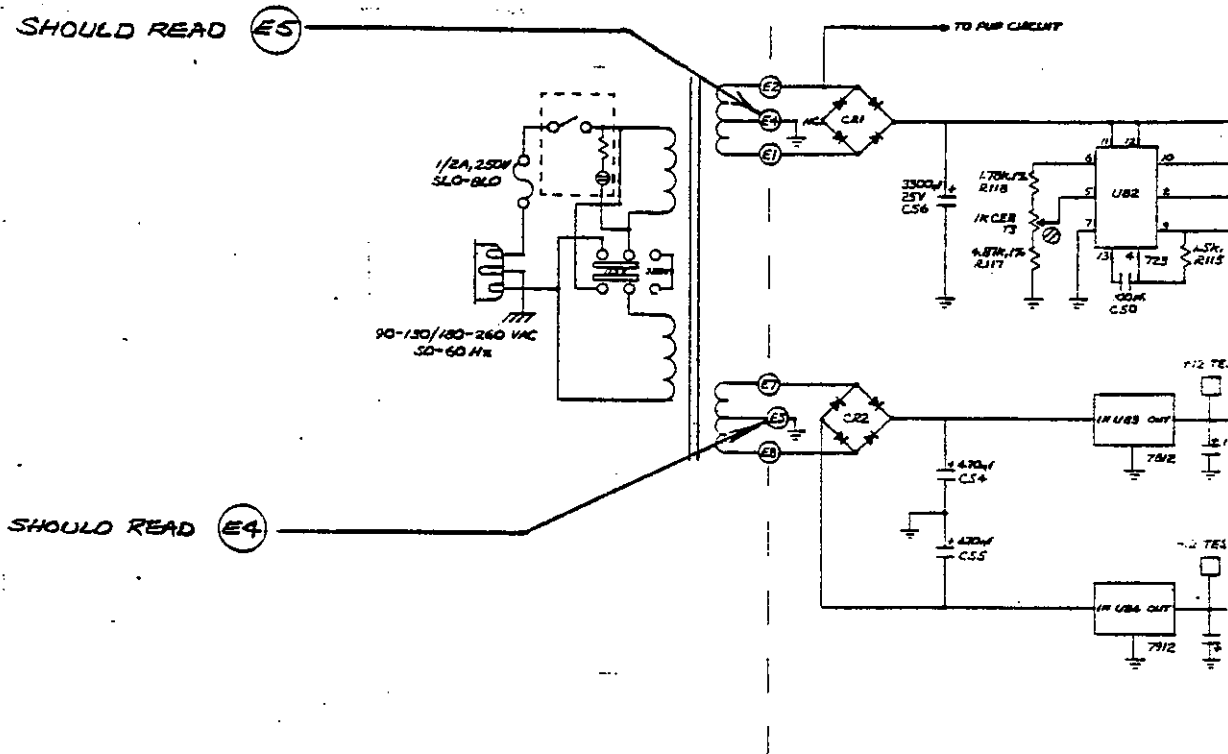
SCHEMATIC 1519 A SHEET 3 OF 3

PIN NUMBERS INCORRECT. SCHEMATIC ONLY.

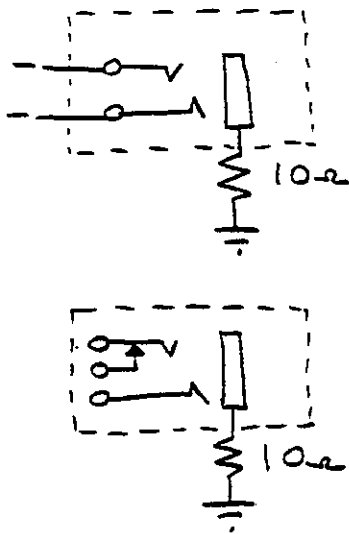
ELIMINATE GROUND LOOPS

- 1) REPLACE JACKS WITH INSULATED TYPES (SWITCHCRAFT N-114B)
- 2) ADD 10 Ω RESISTORS TO GROUND

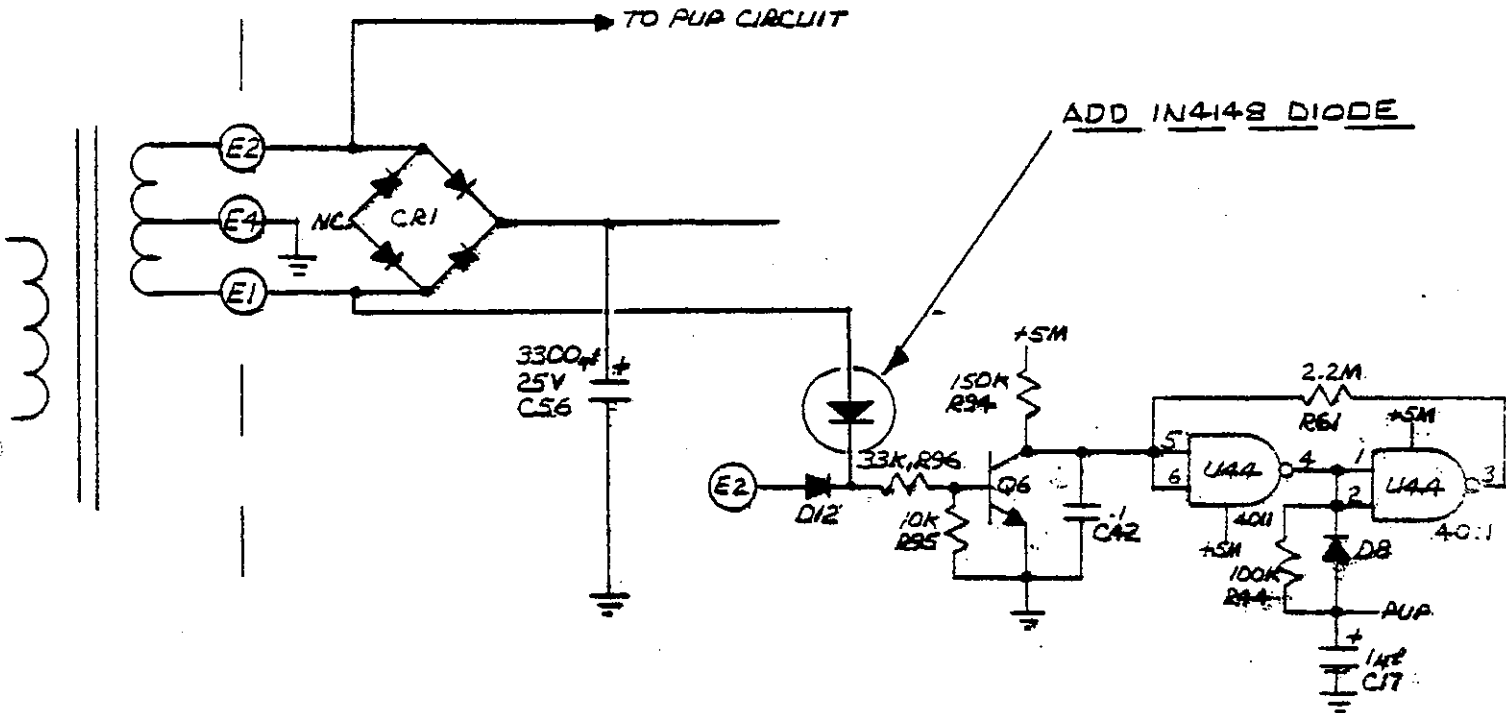
IMPROVE MARGIN OF "PUP" CIRCUIT TO INADVERTENT
TURN-OFF, ESPECIALLY AT 50 HZ

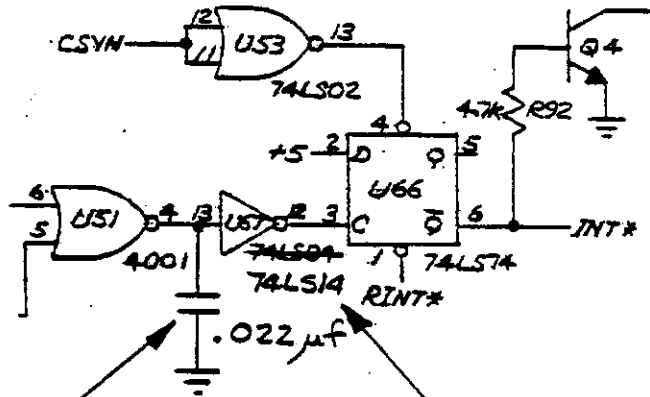
REDUCE SUSCEPTIBILITY OF "CLOCK-IN"
INPUT TO NOISE

1) ADD .022 CAP.

2) CHANGE U67 TO 74LS14

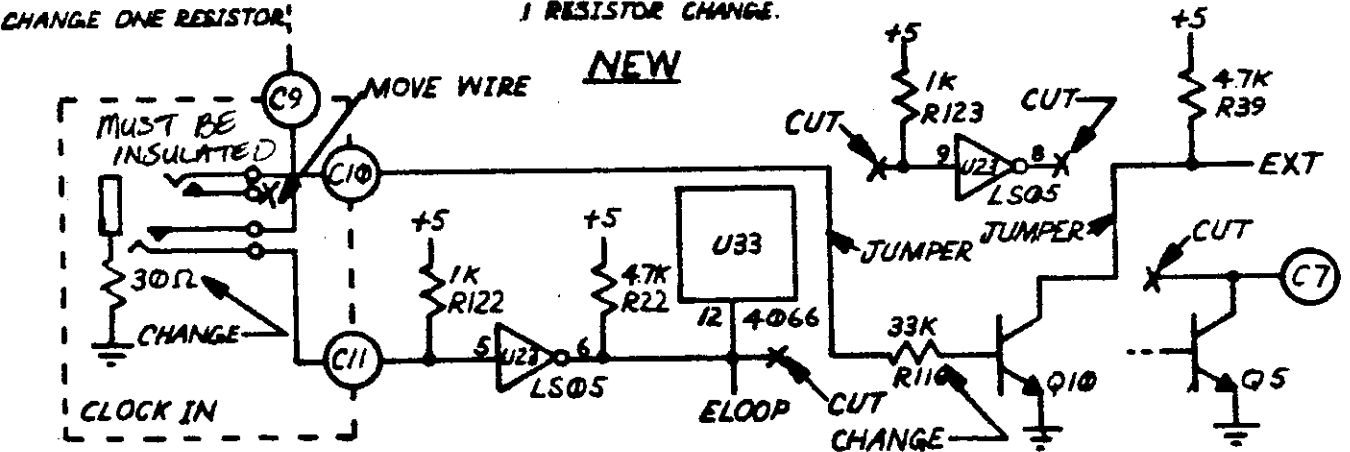
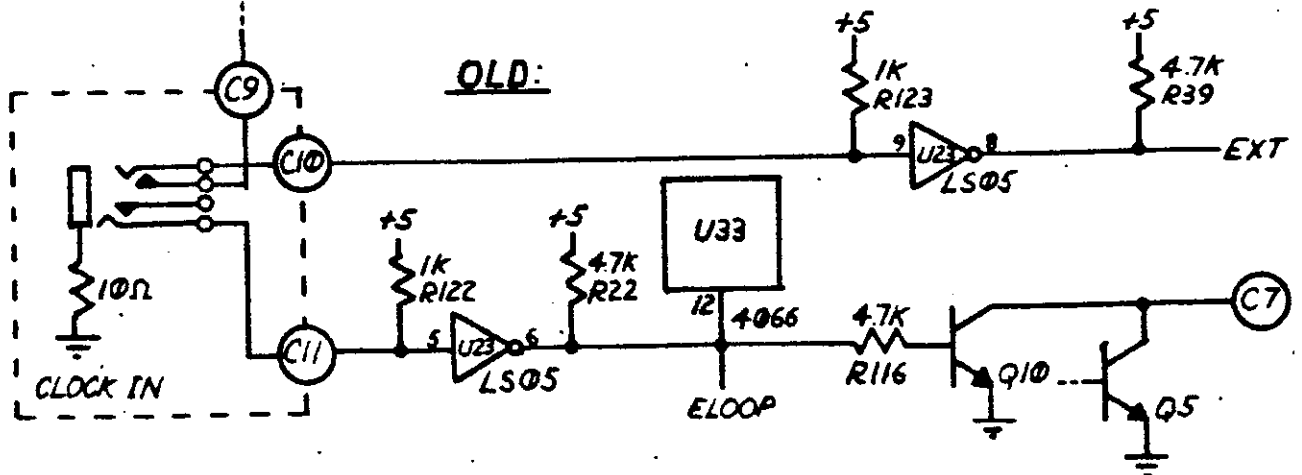
TO ELIMINATE CLOCK NOISE AND GROUND HUM WHEN CONNECTING THE DMX OR DX CLOCK OUT TO THE DSX CLOCK IN.

*NEW: ON BACK PANEL
MOVE ONE WIRE
CHANGE ONE RESISTOR!*

*ON PROCESSOR BOARD:
4 CUTS, 2 JUMPERS,
1 RESISTOR CHANGE.*

NOTE: JACK MUST BE ISOLATED FROM CHAS&TS.

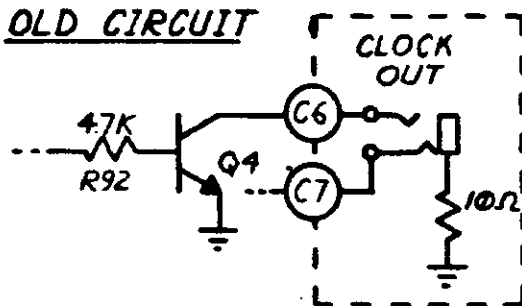
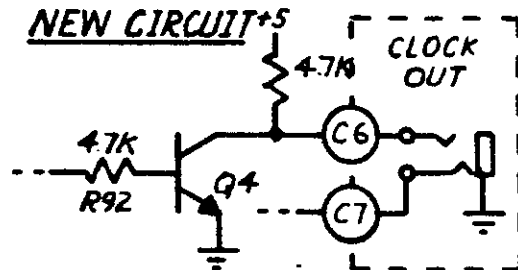
TO ELIMINATE CLOCK NOISE WHEN CONNECTING DSX CLOCK OUT TO DMX CLOCK IN. ALSO ALLOWS TWO DSX'S TO BE CLOCKED TOGETHER WHEN ECO. 211 HAS BEEN IMPLEMENTED.

ADD A 4.7K PULL UP RESISTOR TO THE COLLECTOR OF Q4.

REMOVE 10Ω RESISTOR ON CLOCK OUT JACK AND CONNECT JACK SLEEVE TO GROUND.

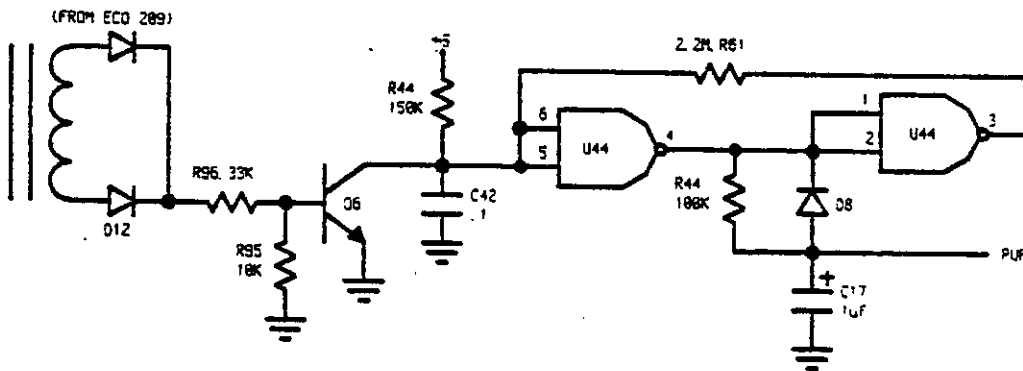
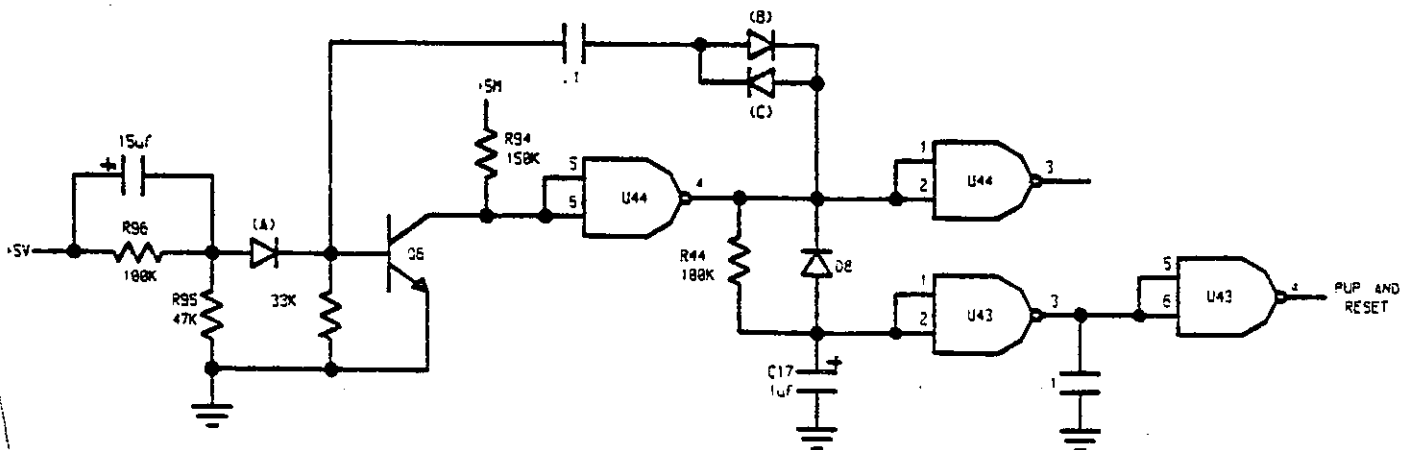
IMPROVE RELIABILITY OF MEMORY RETENTION.

1. REMOVE R61, R95, R96, C42, D12 (IN PRODUCTION, ALSO REMOVE R35, D3, C14).
2. REMOVE DIODE AND WIRE CONNECTED UNDER BOARD TO CONNECTOR E1 AND R96 FROM ECO 209.

3. CUT TRACE GOING TO BASE OF Q6 ON TOP OF BOARD.
4. CUT RESET SIGNAL BELOW FEEDTHRU AT RIGHT OF U65 ON TOP OF BOARD.
5. CUT BETWEEN U43 PIN 2 AND U43 PIN 5 ON BOTTOM OF BOARD.

6. CUT BETWEEN U43 PIN 6 AND U43 PIN 7 ON BOTTOM OF BOARD.
7. CUT BETWEEN U44 PIN 12 AND + SIDE OF C17 ON BOTTOM OF BOARD.
8. PUT 100K RESISTOR (478104) INTO LOCATION R96.

9. PUT 47K RESISTOR (478473) INTO LOCATION R95.
10. CONNECT DIODE (A) (481001) FROM BASE OF Q6 TO TOP OF R95 ON BOTTOM OF BOARD.
11. CONNECT 15 μ F CAP (151024) ACROSS R96 ON BOTTOM OF BOARD. + SIDE TO TOP OF R96.

12. CONNECT ONE SIDE OF .1 CAP (153013) TO BASE OF Q6, BOTTOM OF BOARD.
13. CONNECT 33K RESISTOR (478333) FROM BASE OF Q6 TO BOTTOM OF C42, ON BOTTOM OF BOARD.

14. CONNECT OTHER SIDE OF .1 CAP (153013) TO DIODES (B) AND (C).
15. CONNECT (WITH JUMPER) OTHER SIDE OF DIODES (B) AND (C) TO BOTTOM OF BOARD.
16. JUMPER FROM TOP HOLE OF LOCATION D12 TO +5 AT BOTTOM (ANODE) OF D11.

17. JUMPER TOP (ANODE) OF D8 TO U43 PIN 1 ON BOTTOM OF BOARD.
18. JUMPER FROM U43 PIN 3 TO U43 PIN 5 ON BOTTOM OF BOARD.
19. CONNECT A .1 CAP (153013) FROM U43 PIN 3 TO U43 PIN 7 ON BOTTOM OF BOARD.

20. JUMPER FROM U43 PIN 4 TO U44 PIN 12 ON BOTTOM OF BOARD.
21. JUMPER FROM U44 PIN 9 TO FEEDTHROUGH RIGHT OF U65 ABOVE TRACE CUT IN STEP 4.
22. CONNECT A 150V MOV (480000) TO EACH OF THE PRIMARY WINDINGS OF THE POWER TRANSFORMER:

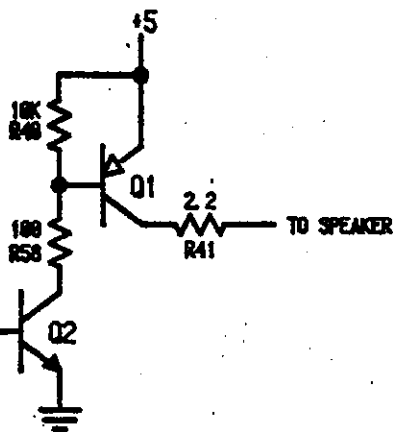
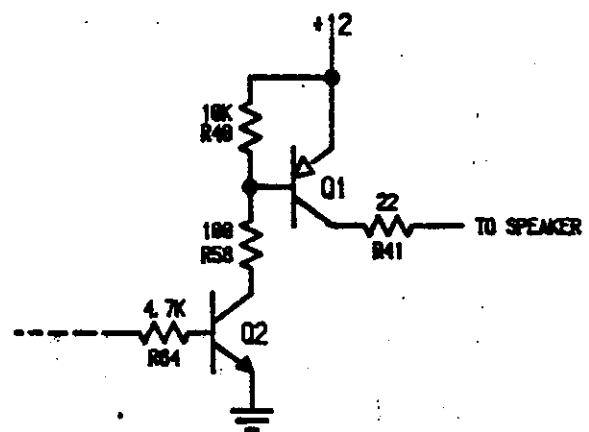
TO REDUCE CURRENT DRAW ON +5 SUPPLY FROM SPEAKER,
WHICH SOMETIMES CAUSES PUP TO FALSE TRIGGER.

1. CUT +5 TRACE GOING TO TOP OF R40 AND EMITTER OF Q1 ON TOP OF BOARD.
2. JUMPER +12 FROM PIN 1 OF r2 RESISTOR SIP TO EMITTER OF Q1.
3. REMOVE RESISTOR R41 (2.2 OHMS) AND REPLACE IT WITH A 22 OHM RESISTOR.
