OBERHEIM ELECTRONICS, INC.
ENGINEERING CHANGE ORDER

ECO NO.
201

DSX

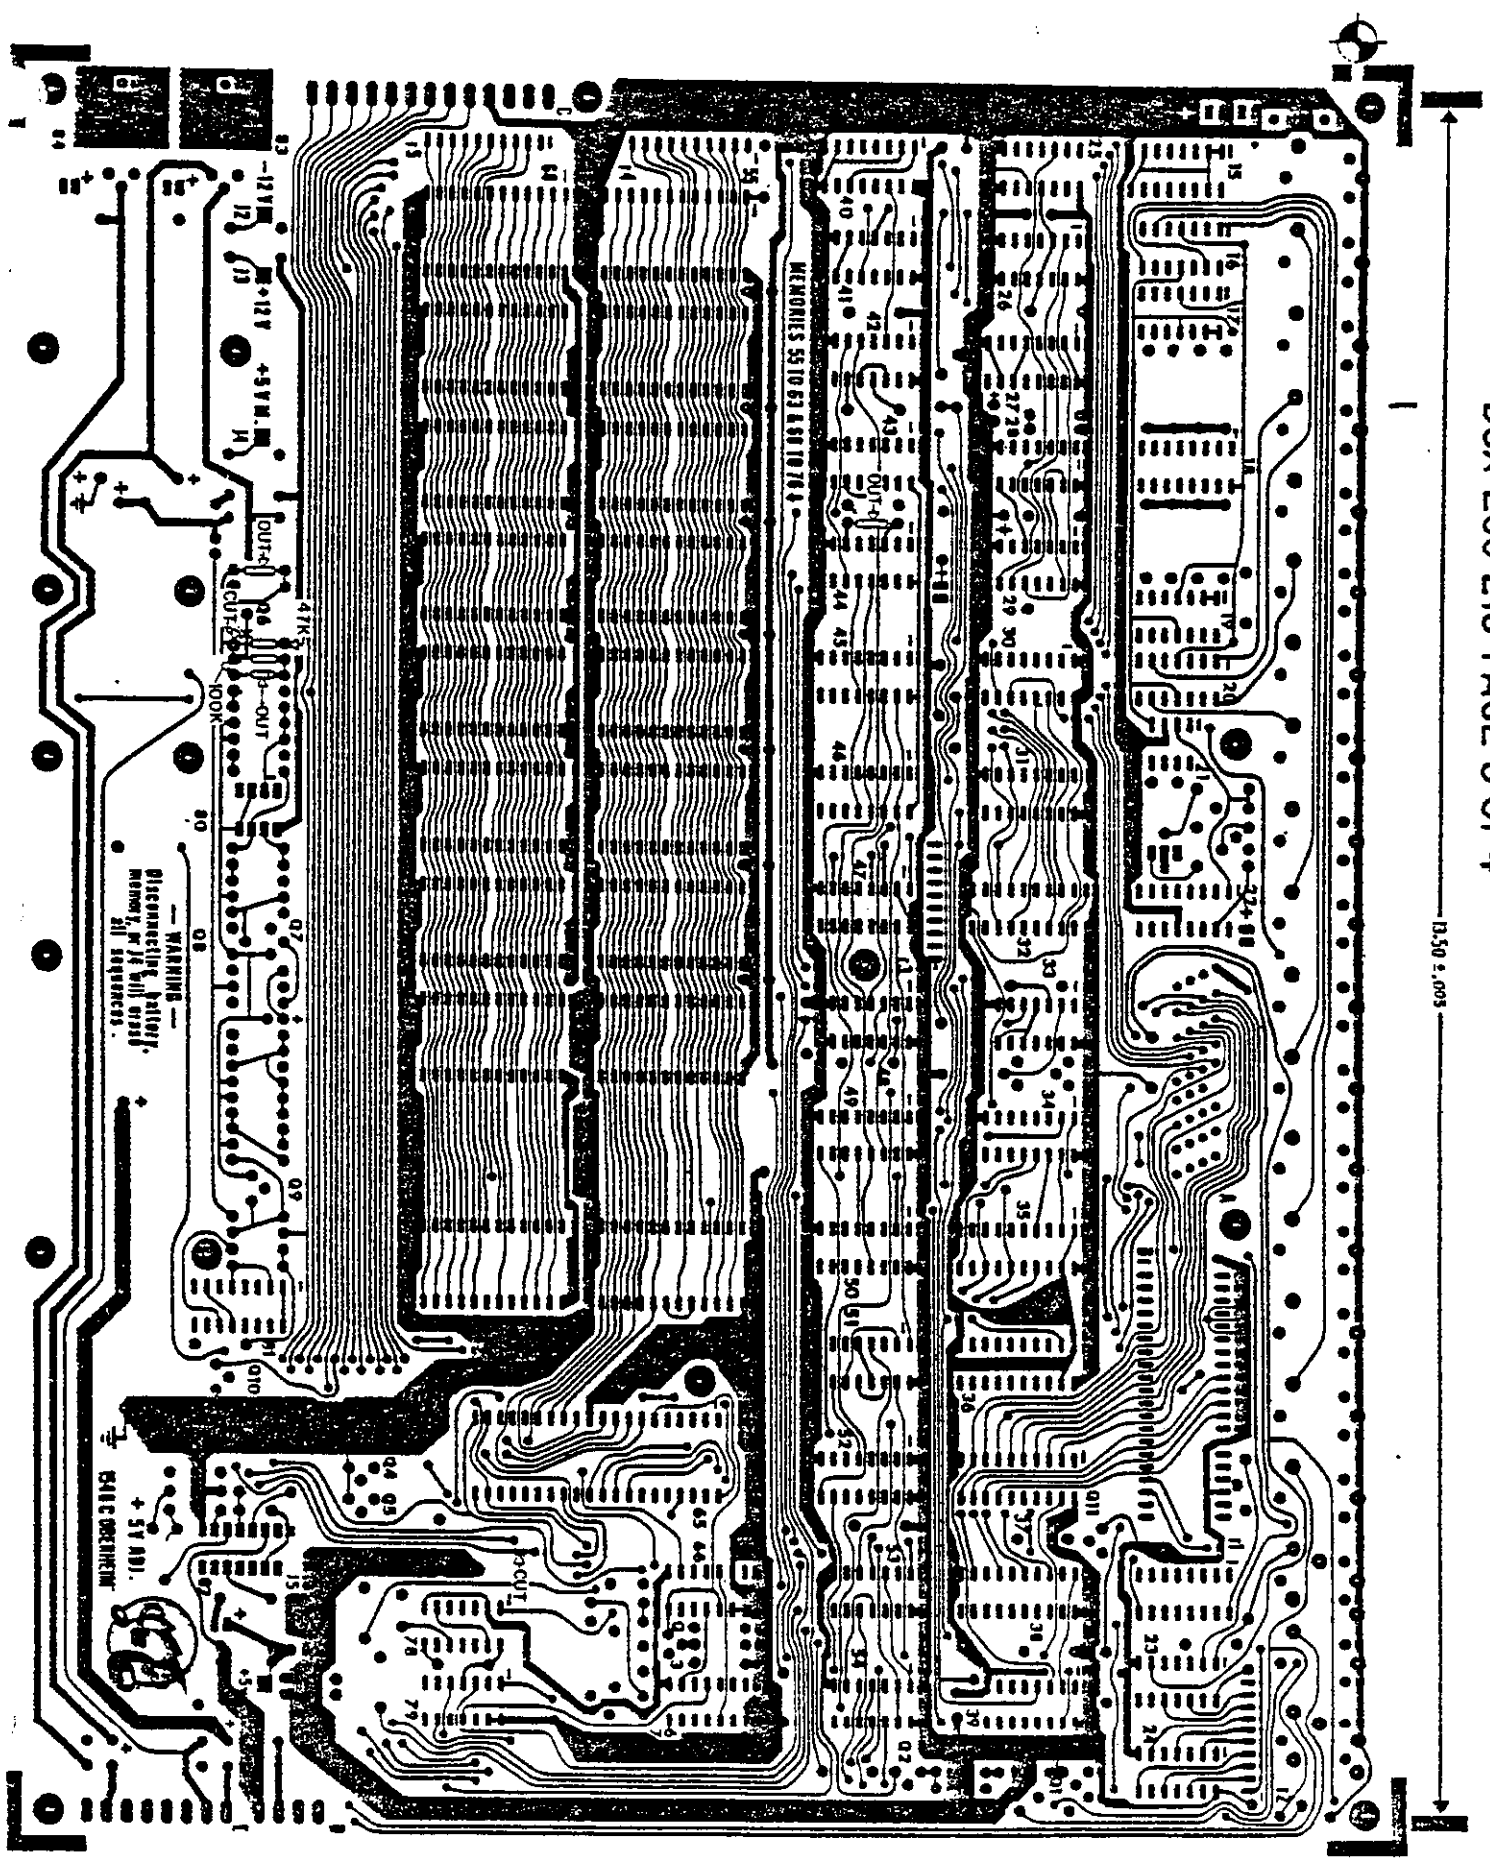
WARNING —
Disconnect battery.
Memory will erase
all sequences.

5418 DOCUMENT
+ 5V ADJ.

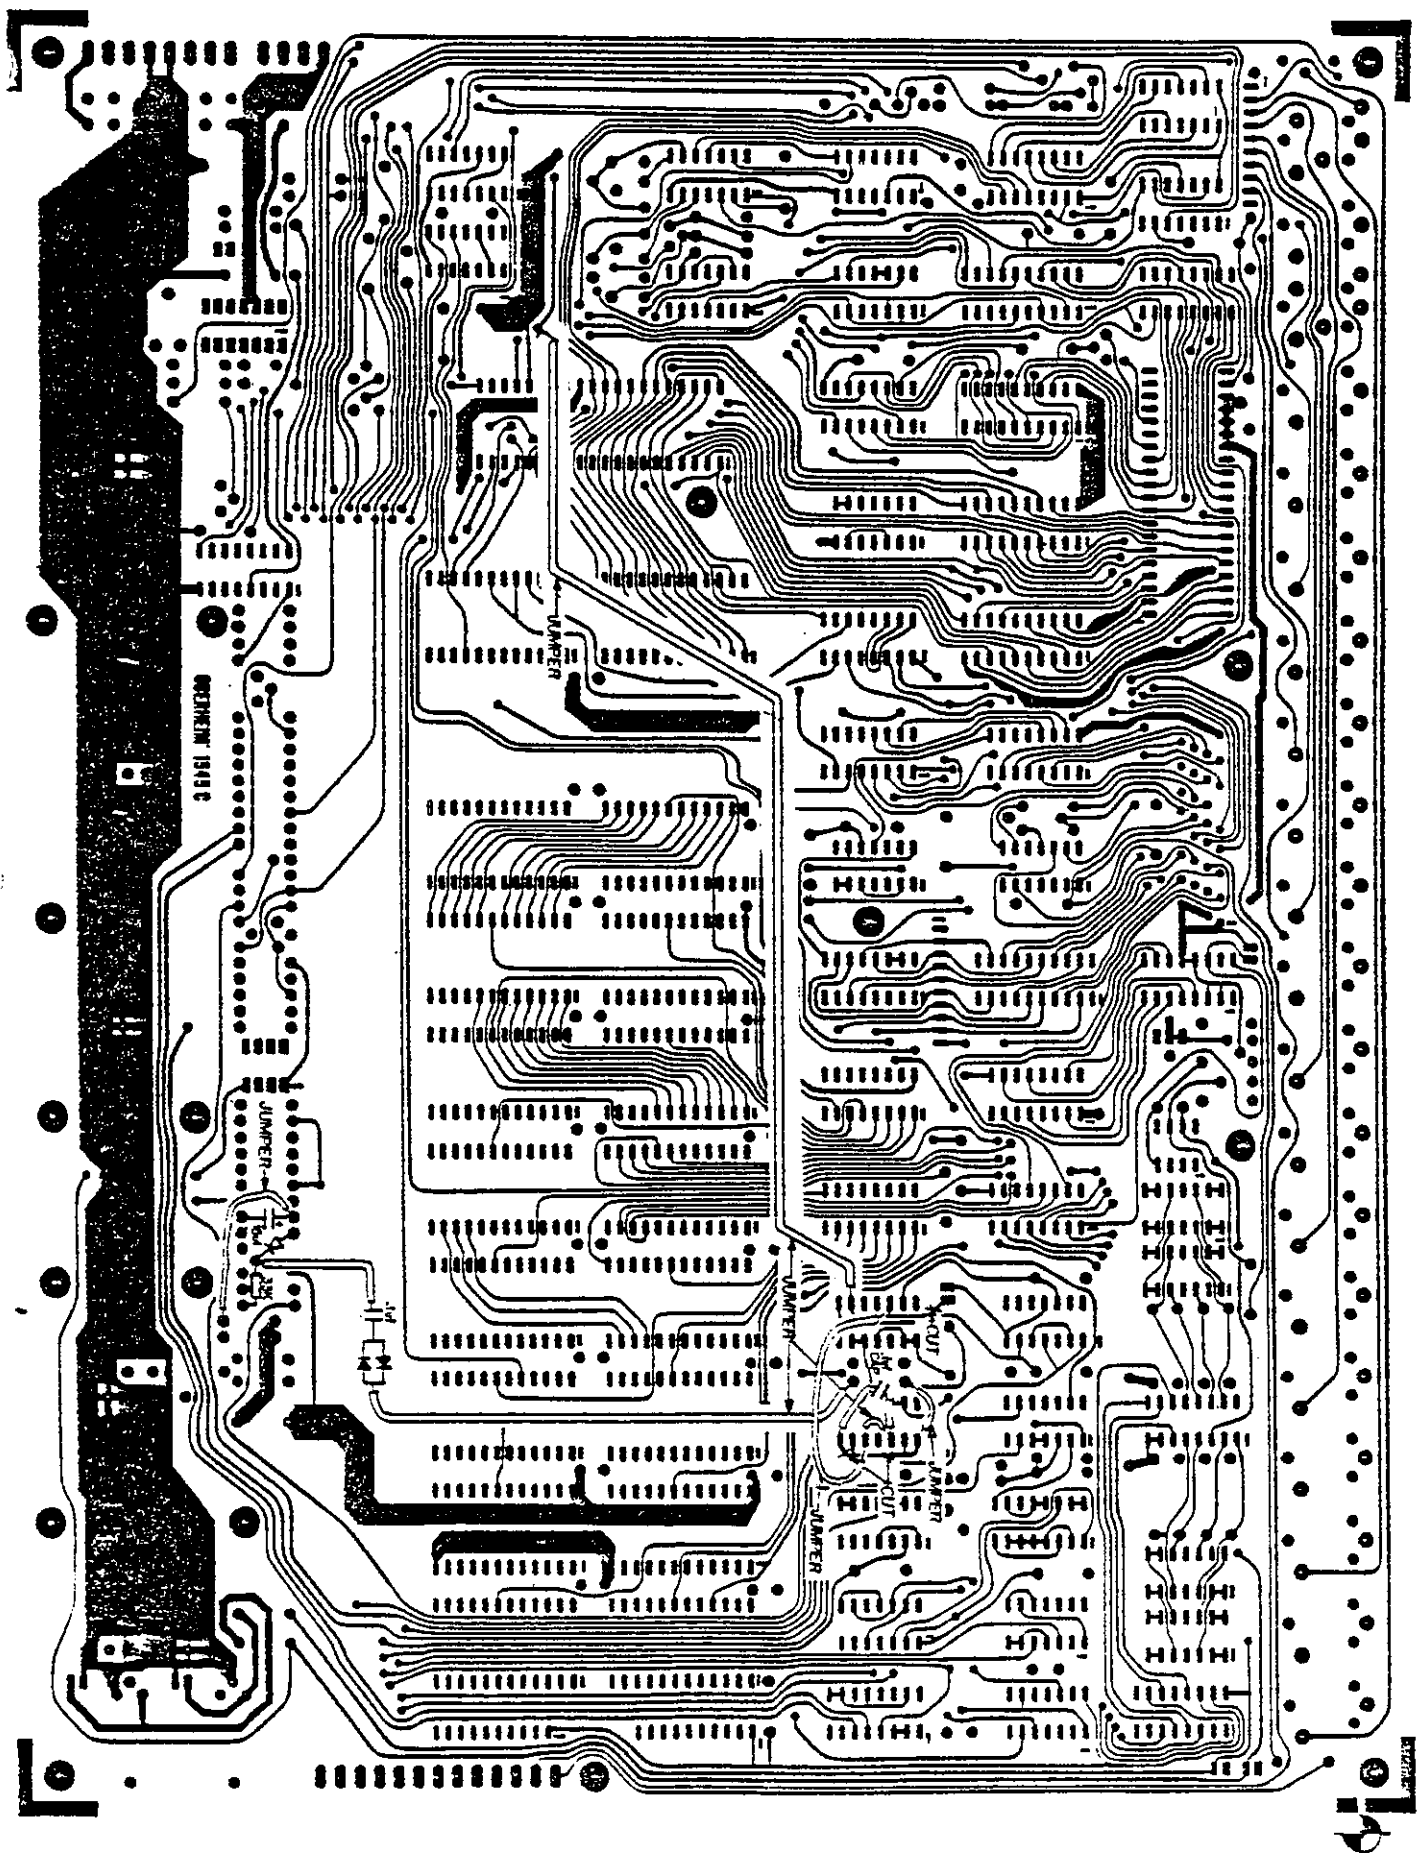
TO REDUCE CURRENT DRAW ON +5 SUPPLY FROM SPEAKER,
WHICH SOMETIMES CAUSES PUP TO FALSE TRIGGER.

1. CUT +5 TRACE GOING TO TOP OF R40 AND EMITTER OF Q1 ON TOP OF BOARD.
2. JUMPER +12 FROM PIN 1 OF r2 RESISTOR SIP TO EMITTER OF Q1.
3. REMOVE RESISTOR R41 (2.2 OHMS) AND REPLACE IT WITH A 22 OHM RESISTOR.
